Manhole Inspection Summary

Manhole # S1900_016MH

Insp Date: **7/9/07 8:45 AM**

Location Address: **2219 BRYANT-WHITTIER**

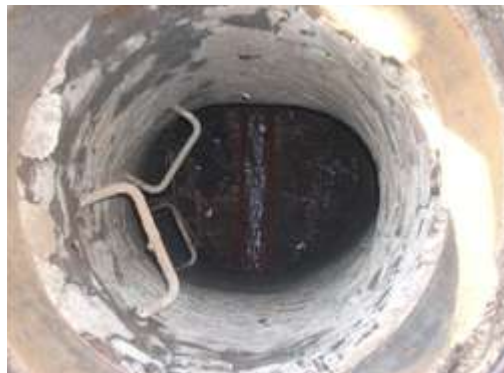
Top View

DEBRIS ON BENCH

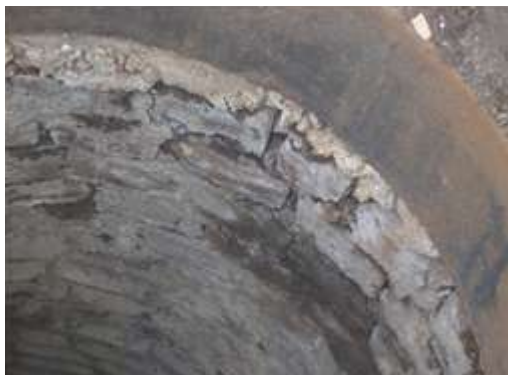
Defect 2

Condition: ☐ Sound ☐ Cracked ☐ Root Intrusion ☐ Loose Brick ☒ **Deteriorated**

DETERIORATION OF CHIMNEY

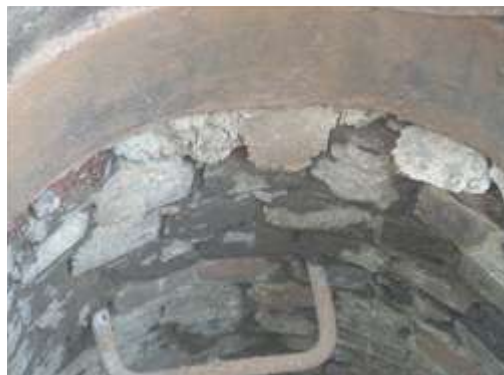
Defect 1

Infiltration: ☐ None ☐ Joint ☐ Cracks ☐ Mortar ☐ Roots ☒ **Wall**

CHIMNEY INFILTRATION AND
DETERIORATED

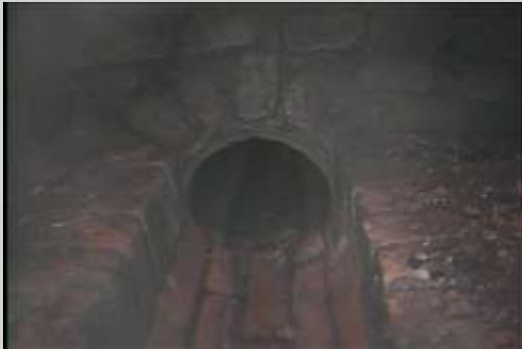
12 O'Clock Outflow

Pipe Height: **8.4** (in.) Rod and Bar (Angled)
Pipe Material: **Clay** ☐ Pipe Lined
Invert Depth: **10.64** (ft.) Flow Characteristics: **Slow**
Deposits: ☒ None ☐ Mud ☐ Sludge ☐ Debris ☐ Grease
Silt Depth: (in.) Deposits Extent:
Infiltration: **None** Pipe Seal Cond: **Sound**

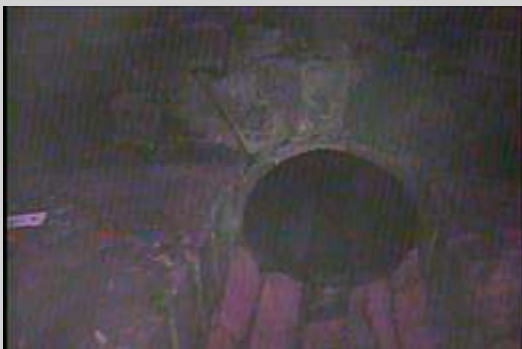
6 O'Clock Inflow

Pipe Height: **8.4** (in.) Rod and Bar (Angled)
Pipe Material: **Clay** ☐ Pipe Lined
Invert Depth: **10.27** (ft.) Flow Characteristics: **Slow**
Deposits: ☒ None ☐ Mud ☐ Sludge ☐ Debris ☐ Grease
Silt Depth: (in.) Deposits Extent:
Infiltration: **None** Pipe Seal Cond: **Sound**
